OHIO RIVER BASIN
RILEY RUN, ELK COUNTY

RILEY RUN DAM
NDI No. Pa. - 386

PHASE I INSPECTION REPORT
NATIONAL DAM INSPECTION PROGRAM.

11 AUGUST 1978

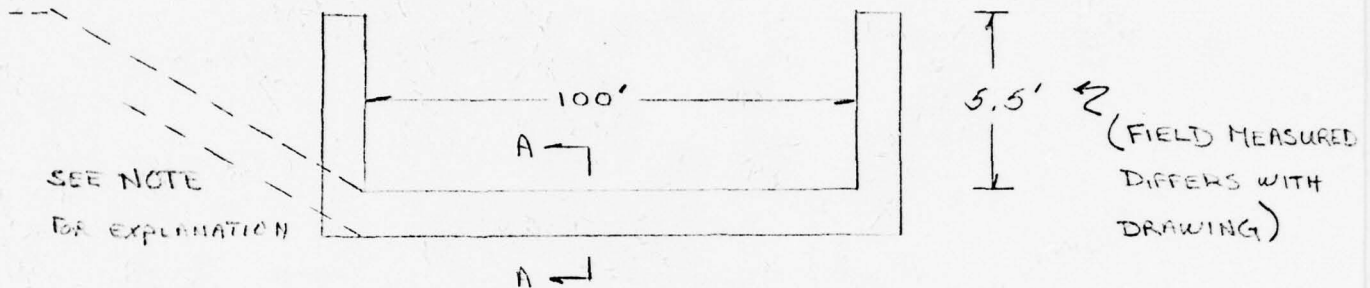
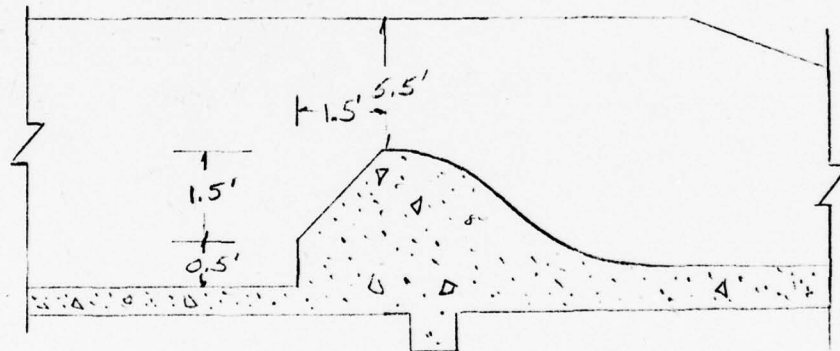
SPILLWAY CAPACITY

NOTE: DIMENSIONS ARE TAKEN FROM DRAWING DATED
6-10-57 by J.C. MORIN, REG. ENGR. # 3868
LOCK HAVEN, PA. (VERIFIED DURING INSPECTION)

ASSUME VERTICAL SLOPE ON RIGHT SIDE OF SPILLWAY.
ACTUAL SLOPE (AS INDICATED BY DESIGN DRAWING AND
VERIFIED IN THE FIELD) IS DEPICTED BY THE DOTTED LINE

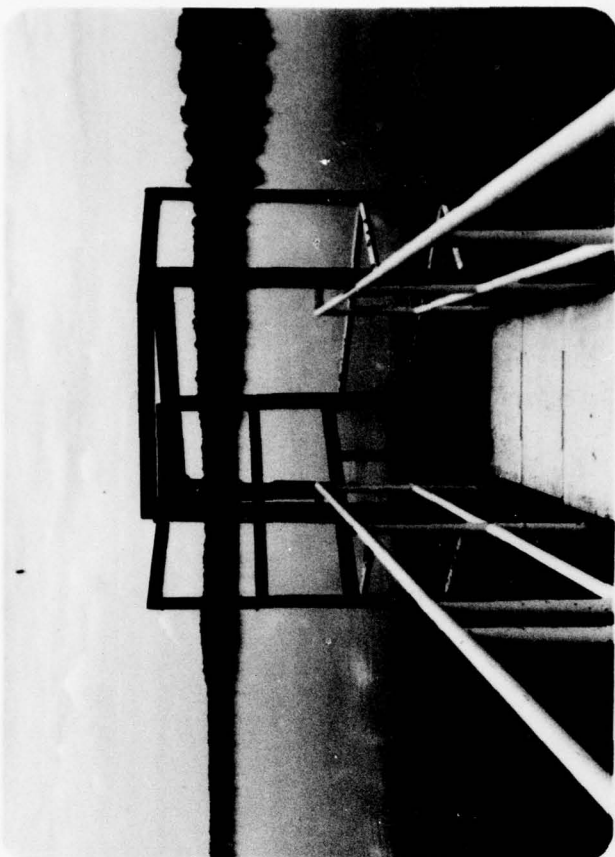
According to PENNTECH Paper personnel, there are no formal manuals containing information regarding operational procedures at the facility. Processing effluent (4 MGD) is pumped into the reservoir and in turn supernatant (4 MGD) is decanted off through the outlet works. The supernatant is directed into the small sedimentation pond just beyond the toe before passing downstream (see Photograph 9). Excess inflow is discharged over the emergency spillway.

PHOTOGRAPH 9 Closeup view of the weir located on the downstream end of the stilling basin. Water passing over the weir is directed into the natural downstream drainage. The embankment is shown in the background of the photograph.
